## Strengthening of Parking Garage Slab

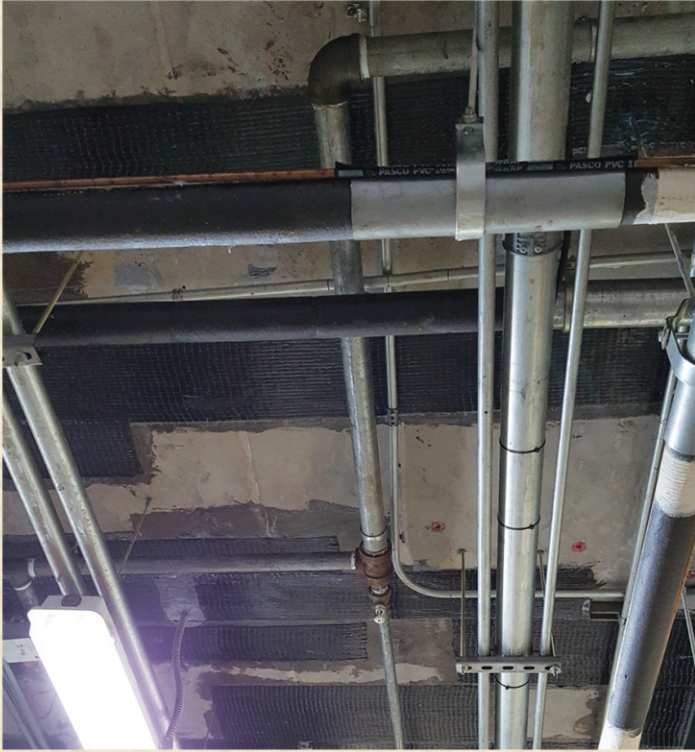
Installation of FRP System through existing MEP

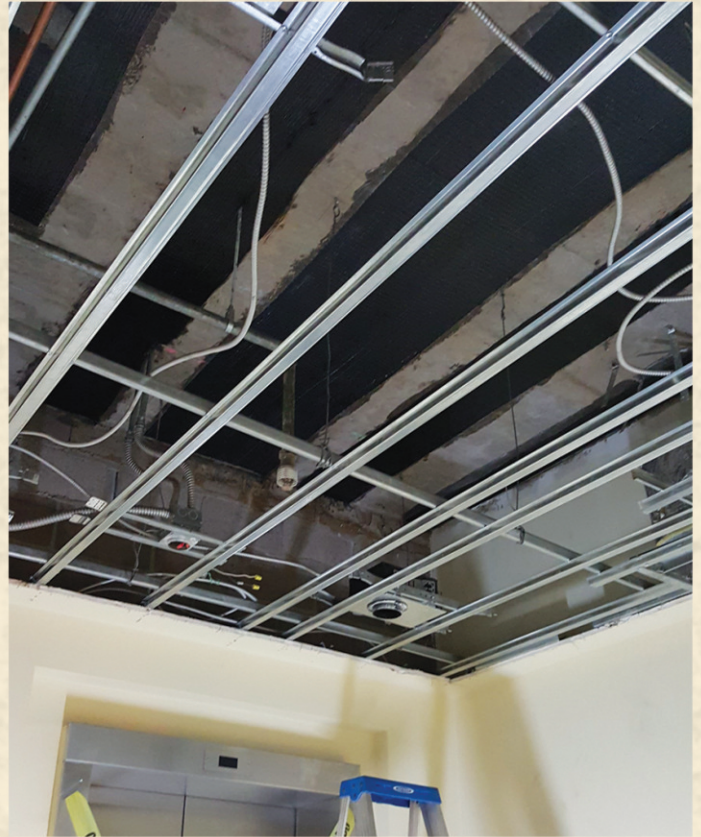
Installation of FRP System above finished elevator lobby
